TRANSMISSION & DISTRIBUTION TM WORLD

Copper Theft

Utilities use an affordable, easy-to-deploy system to aid in apprehending copper thieves.

By **Scott W. McKenzie**, *Northeast Utilities*, and **Brian K. Smith**, *Progress Energy*

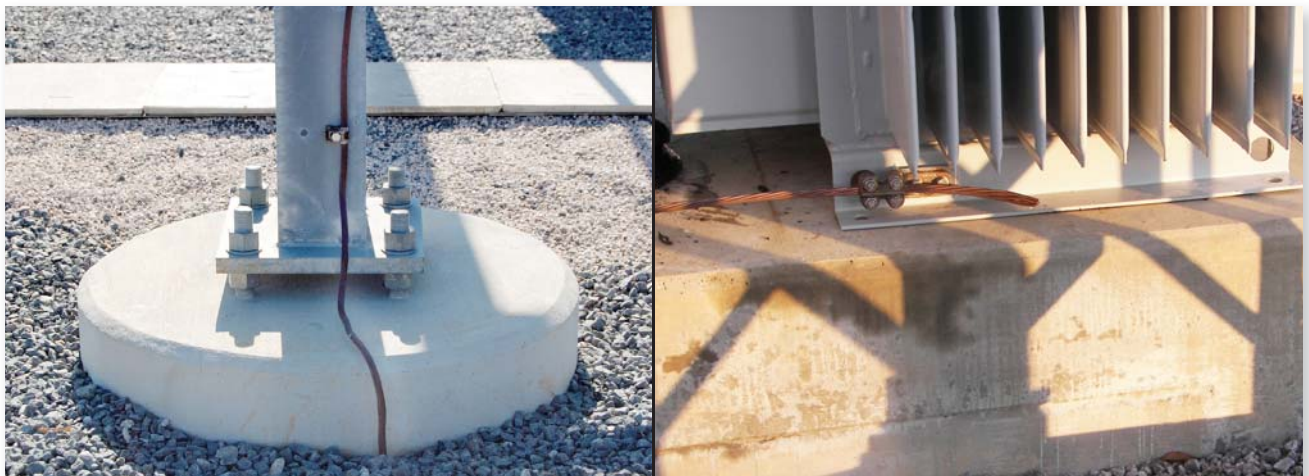
Thieves will steal coils of copper wire if they can get them; otherwise, they will go after the copper making up the grounds (left). Often, the criminals will just cut the sections off (right). The more enterprising thieves will tie the ground to a truck and see how much can be exposed before cutting.

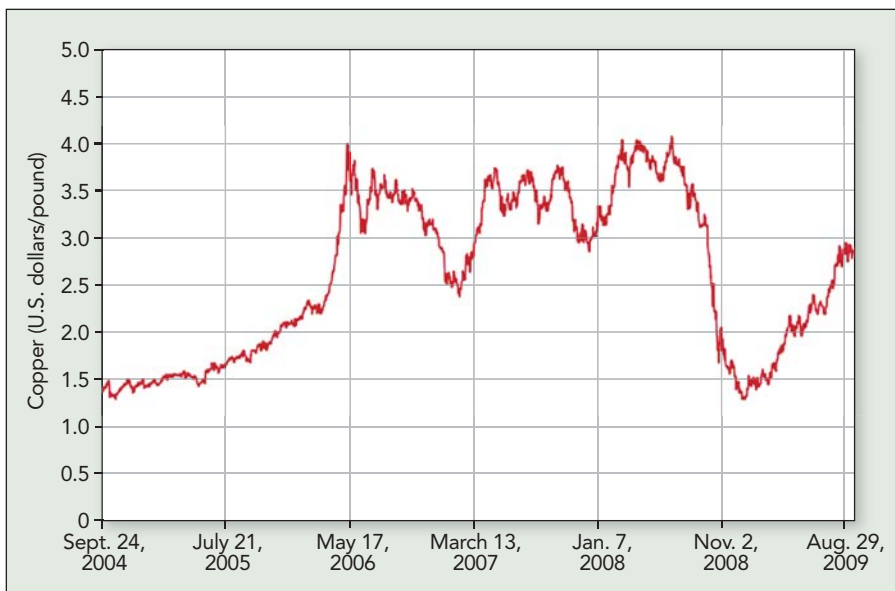
The price of copper over a five-year span.

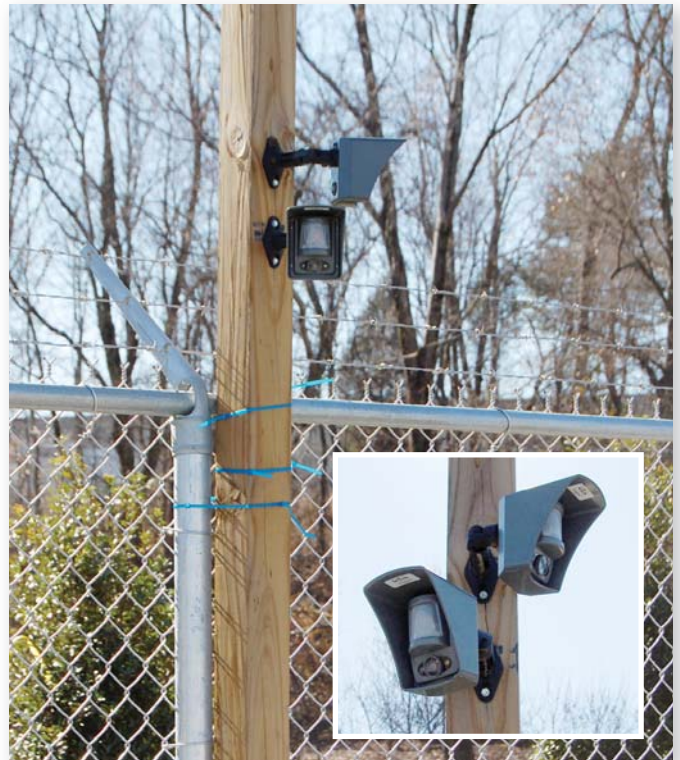
The cameras are easy to set up. In this case, mounting posts are secured to the station perimeter fence with the cameras attached. Since the system is wireless, it can be deployed and re-deployed to suit changing circumstances.

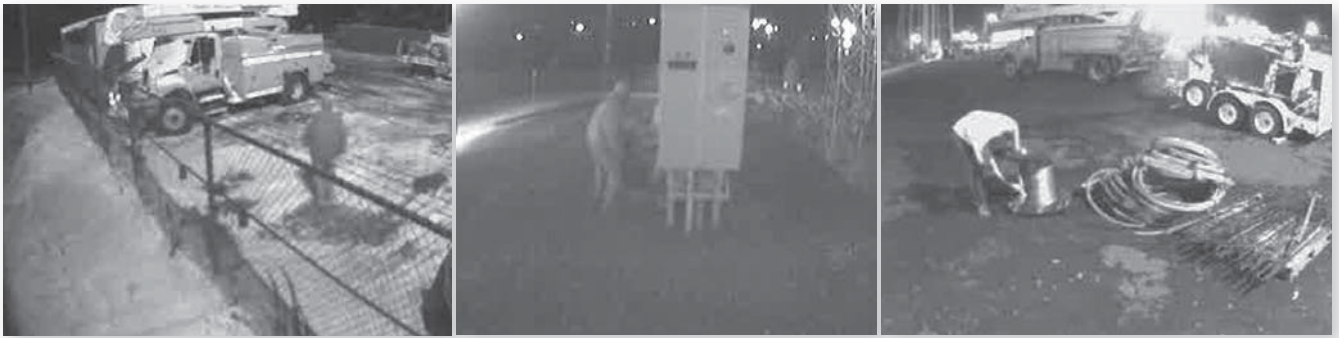
Images such as these are captured by the MotionViewers. Infrared illumination allows the devices to detect motion and then provide a video clip of the action. This is transmitted to a manned monitoring station, which then places a call to the police to report a robbery in progress. Video clips of the apprehension have also been recorded.

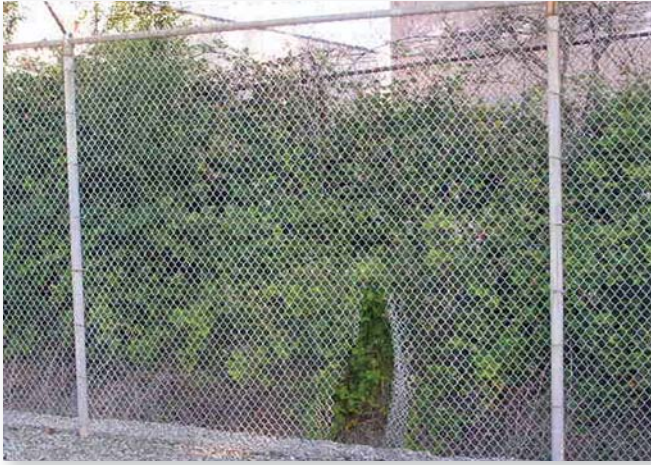
A typical perimeter security breach. Photo courtesy of BC Hydro.
